Junma Services Pte Ltd

MAN B&W L23/30 Roller Guide Damage for Valve Gear & Fuel pump

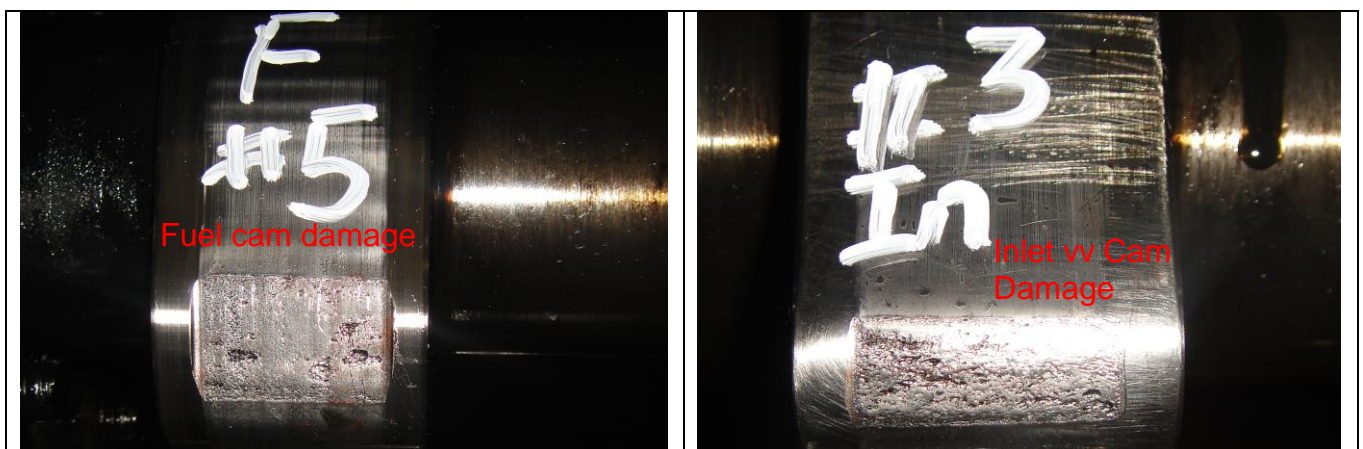
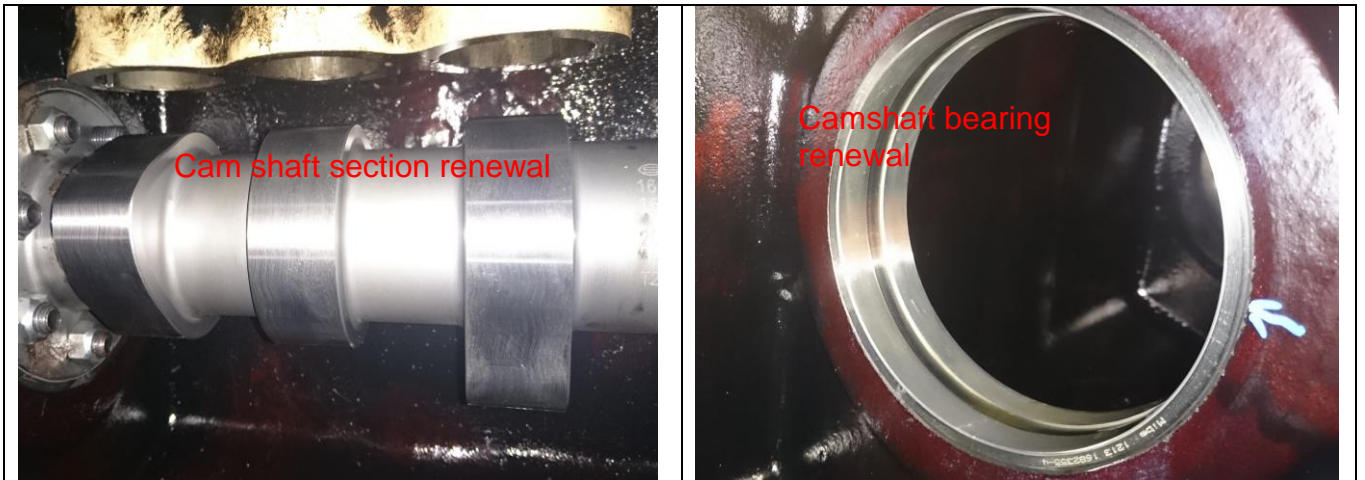
Recently, we have experienced cases that MAN B&W L23/30H engine roller guide damage during general inspection. Such kind of damage may lead to consequential damage to cam and camshaft and cause blackout onboard vessel. We therefore strongly recommend to carry out routine inspection and necessary maintenance as preventive measure.

2. If any cam damage or even light scoring marks was found during inspection, it is necessary to dismantle roller guide for inspection, following measures should be take into account when doing roller guide overhaul:

- Carry out crack test and replace any cracked roller guides.
