Current status of  
NOTCHED WIRE ELEMENT  
for LO 2nd MAXFILTER  
and future proposal

document author: Hayato Serizawa  
Update date: 2024.11

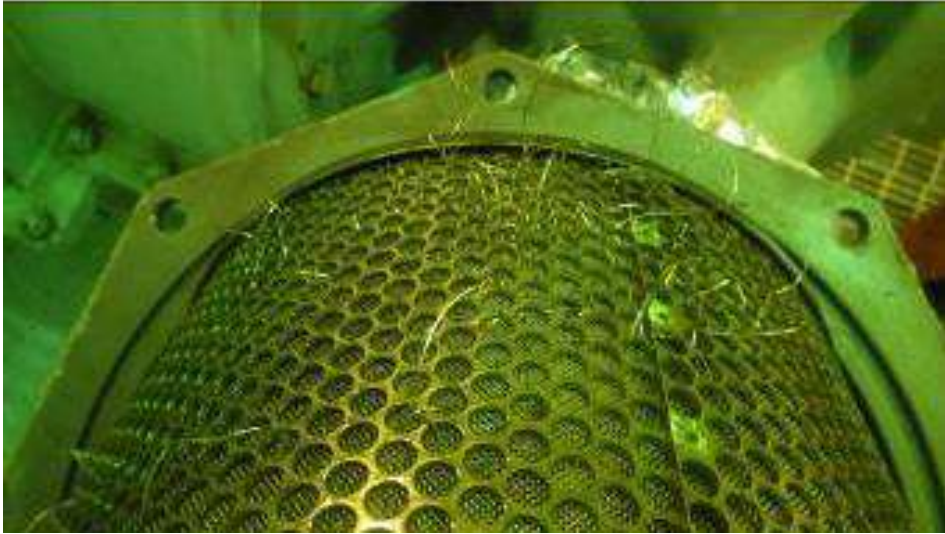
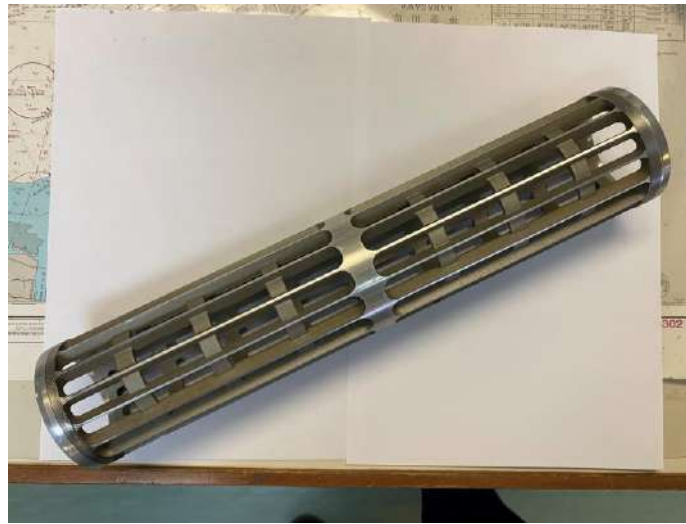
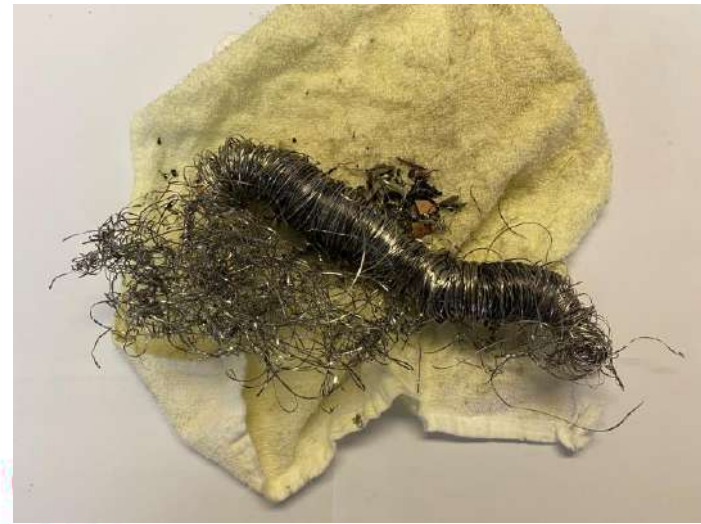
# ELEMENT Damage Case (1) - 1

Occurred in June 2023. A wire as shown in the left figure was added to the FILTER in the LO main pump strainer on a ship in service in 2002. Based on the flow of the line, it was assumed that the wire had frayed on the ELEMENT of the LO 2nd MAXFILTER. Emergency docking was performed in August and the ELEMENT was confirmed to be without any wire as shown in the figure below and the ENGINE OH and ELEMENT were replaced. In the meantime, the vessel was off-hire (inoperable).

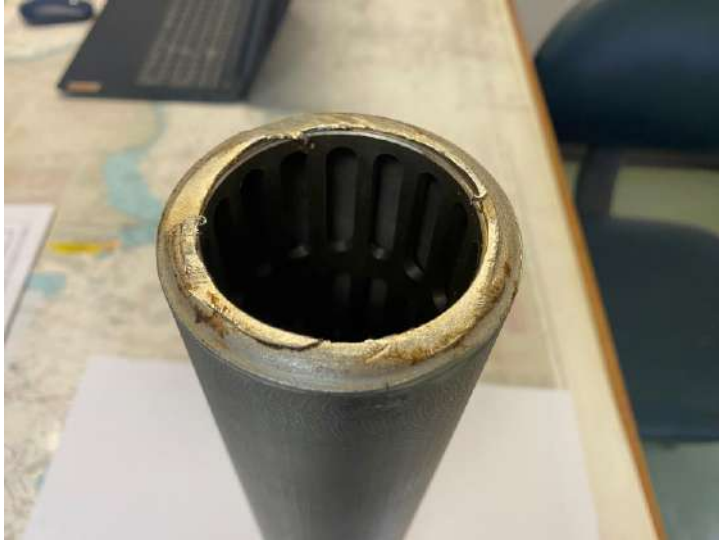
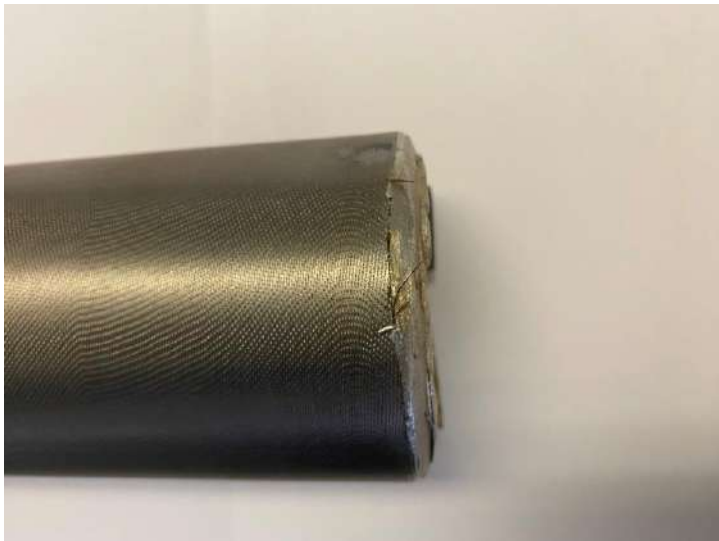
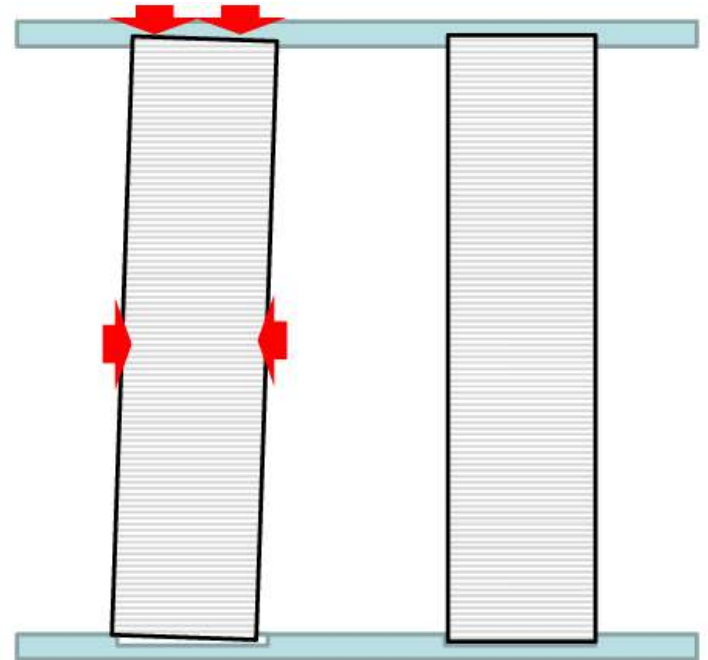
# ELEMENT Damage Case (1) - 2

Abnormal wear of the casing, possibly caused by poor installation, was observed on the same vessel. In the case of the situation shown on the left, because of the possibility of reduced filtration performance and unexpected damage to parts of the casing, we recommended and implemented immediate replacement of the casing.

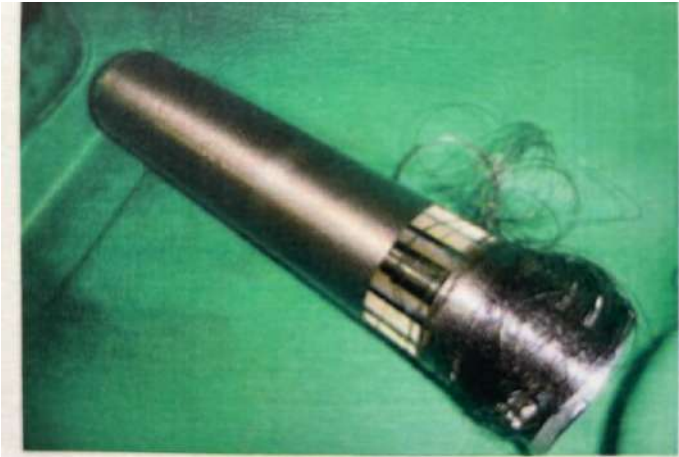
Fig.1 Damaged filter element

Occurred in April 2024. On a ship commissioned in 2009, an open inspection according to PMS was performed and 8 ELEMENTS were found in an abnormal condition, as shown in the left figure. As there were only two spare ELEMENTS on board, the filter was stopped and filtered with a BYPASS FILTER. The ELEMENT was immediately replaced with a new one.

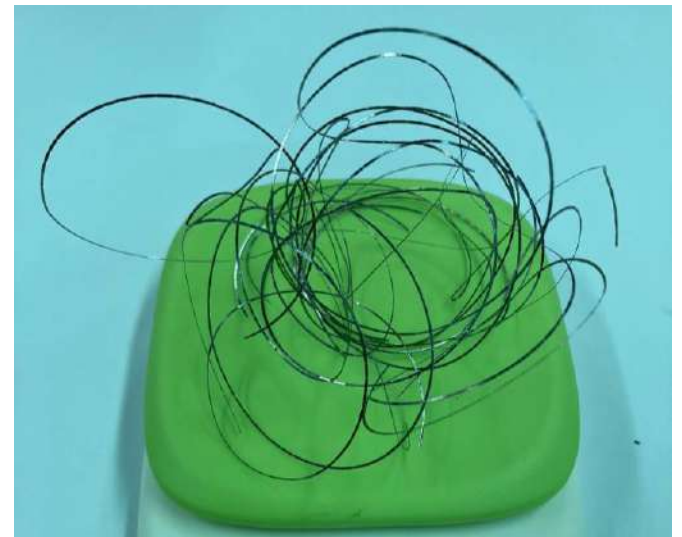
After entering service in 2009, only 3 ELEMENTS have been delivered in 15 years (18 on board). Frayed wires were also found on the SLUDGE COLLECTOR, as shown on the right.

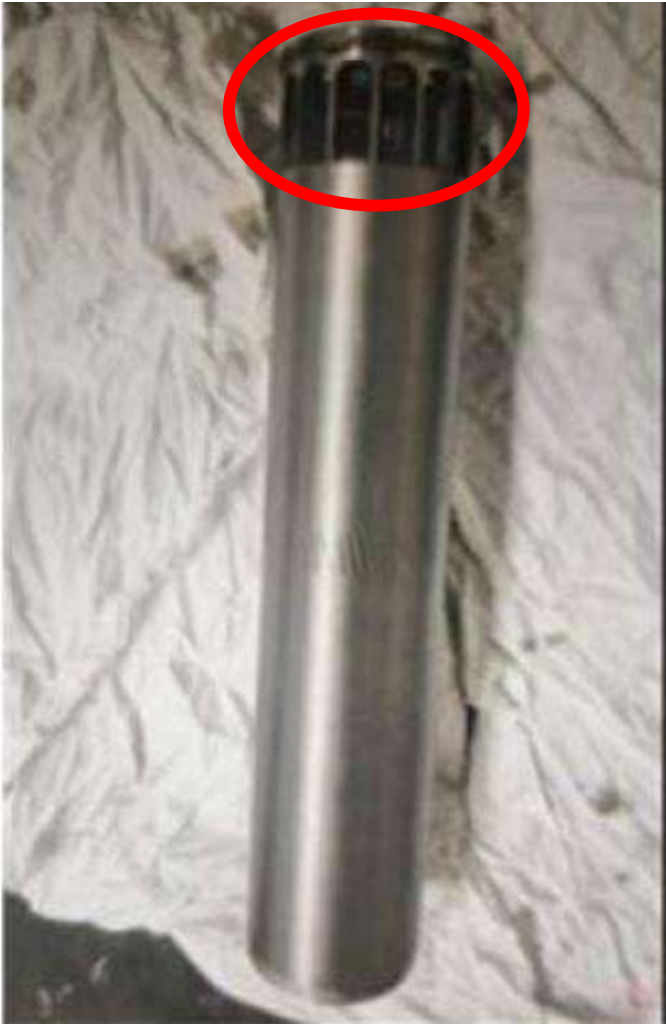
# ELEMENT Damage Case (3)

Occurred in April 2024. On a ship that entered service in 2008, a rotational failure of the ENGINE was confirmed. After inspecting each part, an ELEMENT with a wire falling off was found, as shown in the left figure.

The ENGINE was immediately overhauled under the guidance of the ENGINE manufacturer.

All the wires were replaced with new type of WEDGE WIRE ELEMENT.

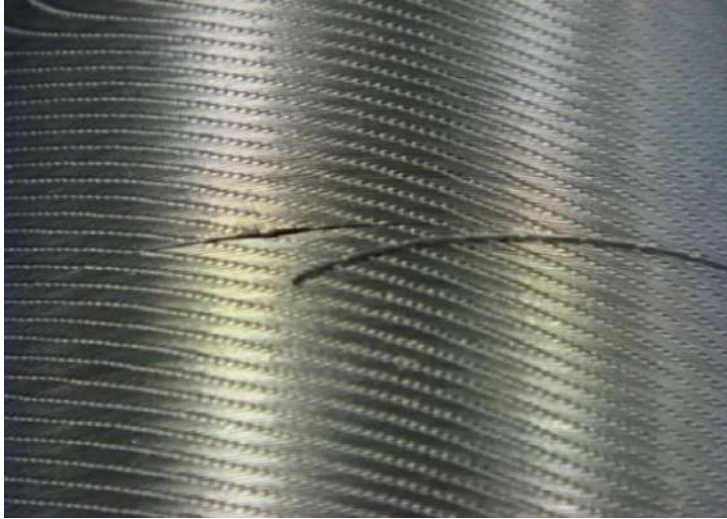
WIRE is broken and  
there is a gap.

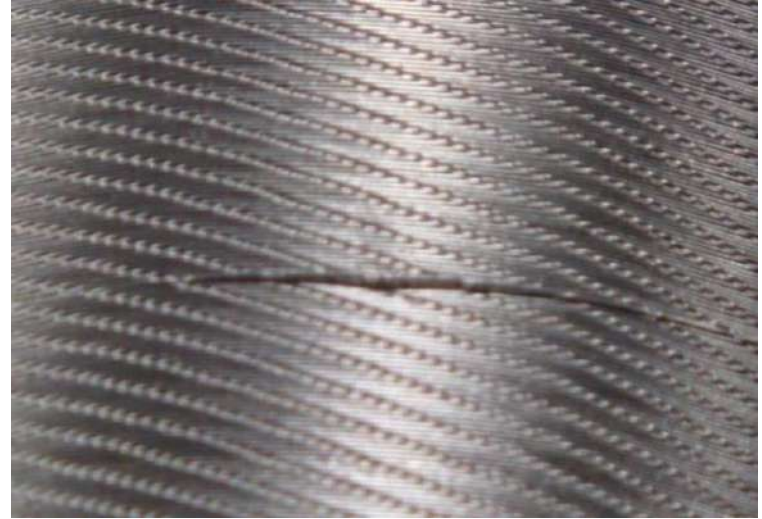
WIRE is raised and  
has gaps

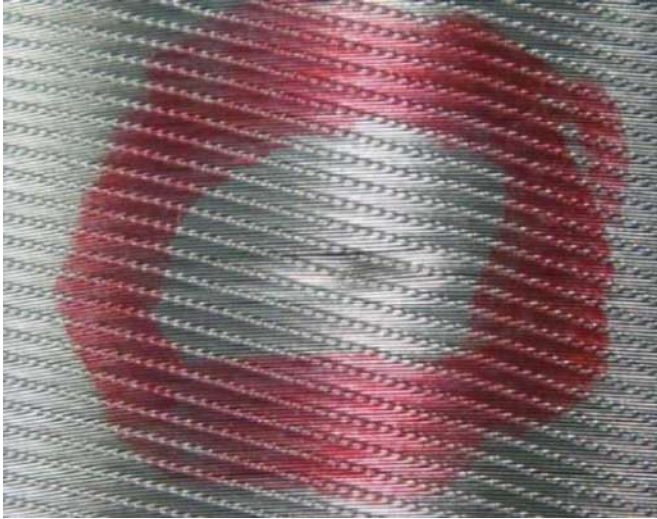
ELEMENT has been dropped or otherwise damaged, such as dents or other external damage.

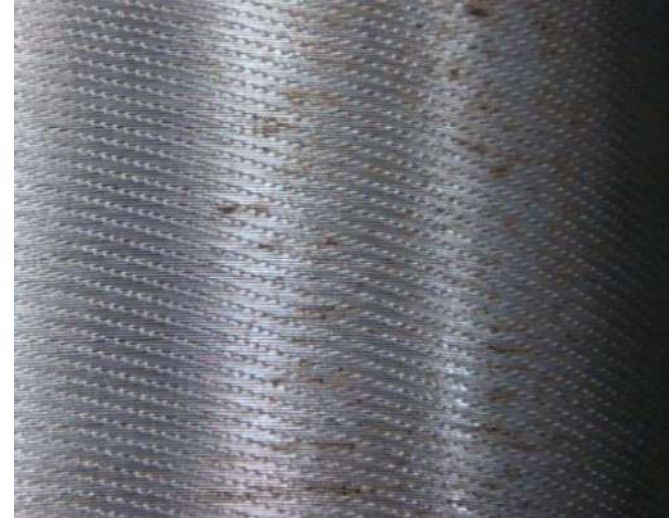
ELEMENT oil in storage has dried up and is discolored.
