Current status of  
NOTCHED WIRE ELEMENT  
for LO 2nd MAXFILTER  
and future proposal

document author: Hayato Serizawa  
Update date: 2024.11

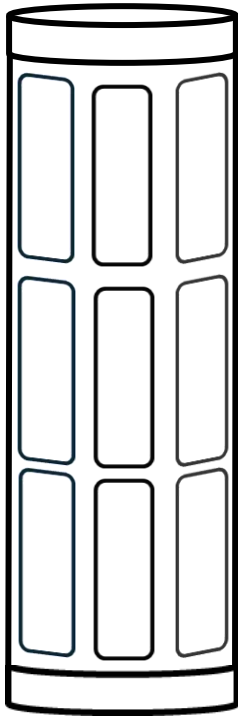
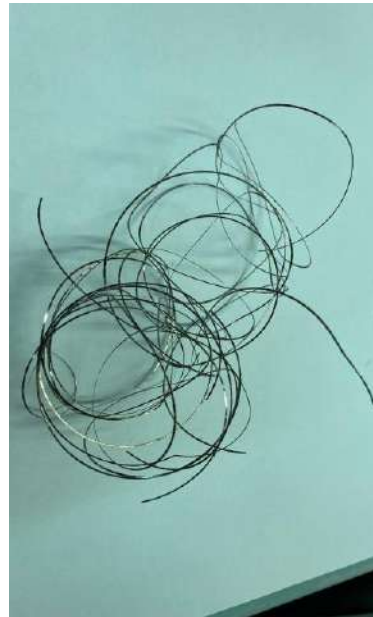
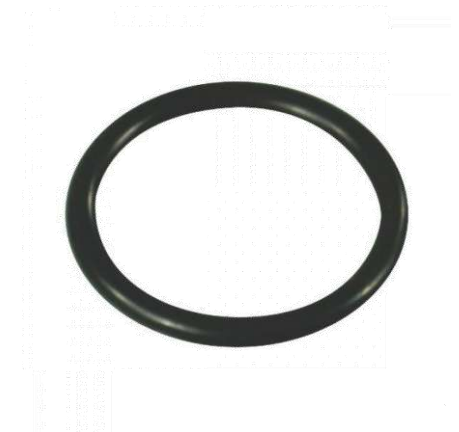
SUS304 wire is wound around the casing and secured by welding only the start and end points

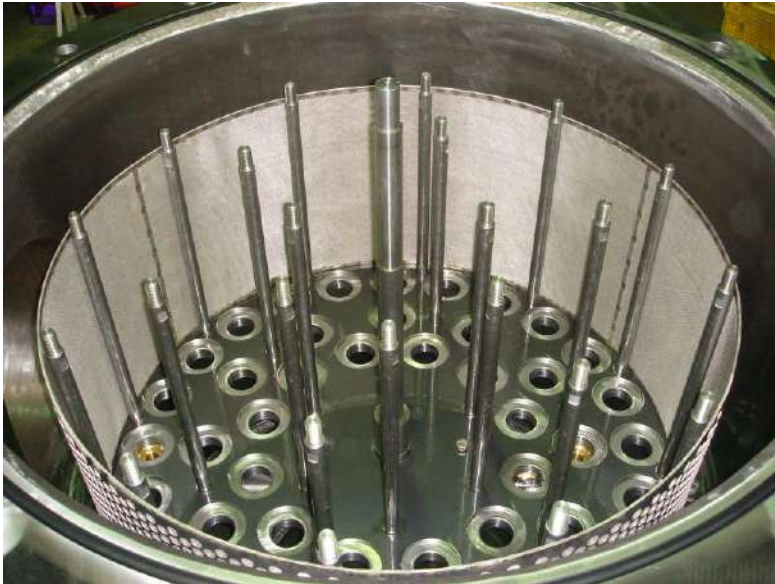
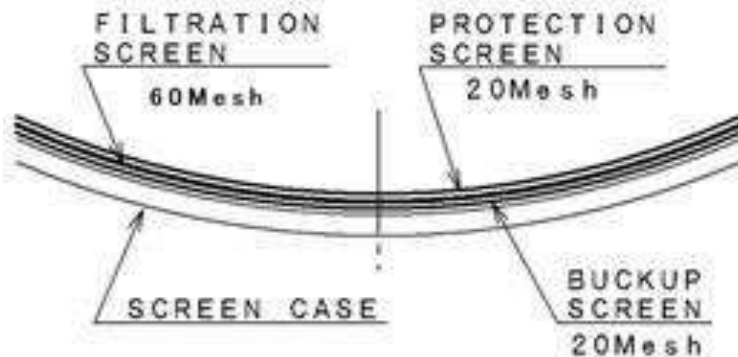
DETAIL OF SCREEN

In the unlikely event of a WIRE fraying, another screen will be installed in the main unit to capture the frayed WIRE before it heads to the main engine or LO sump tank.

Please check the condition of the ELEMENT when replacing or cleaning to ensure that it is not damaged or clogged.

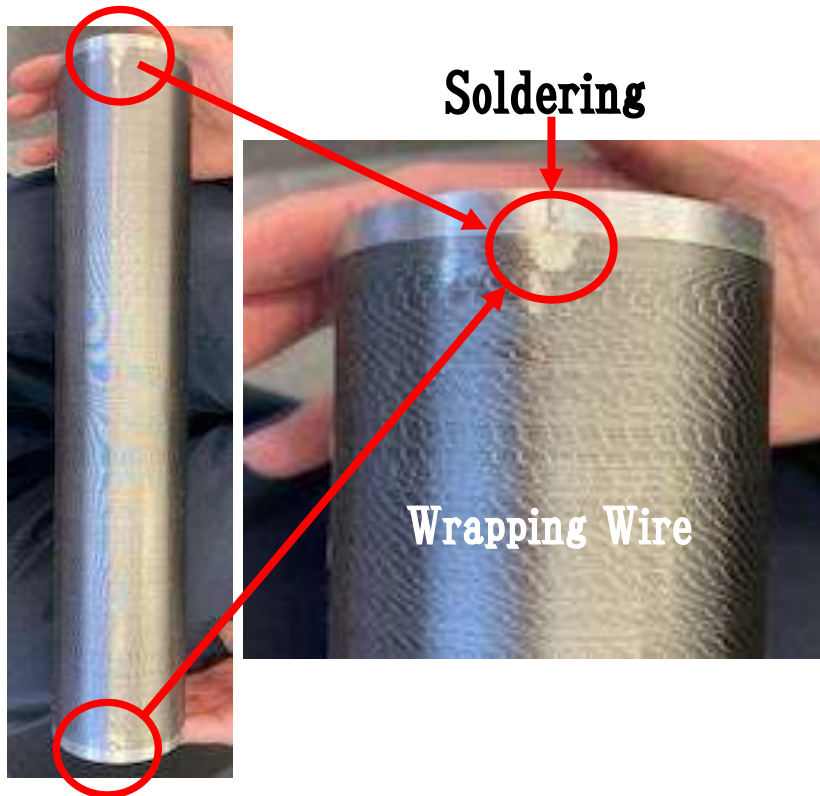
NOTCHED WIRE ELEMENT

Soldering the start and end points of the wire

- Structure that wraps the wire around the casing

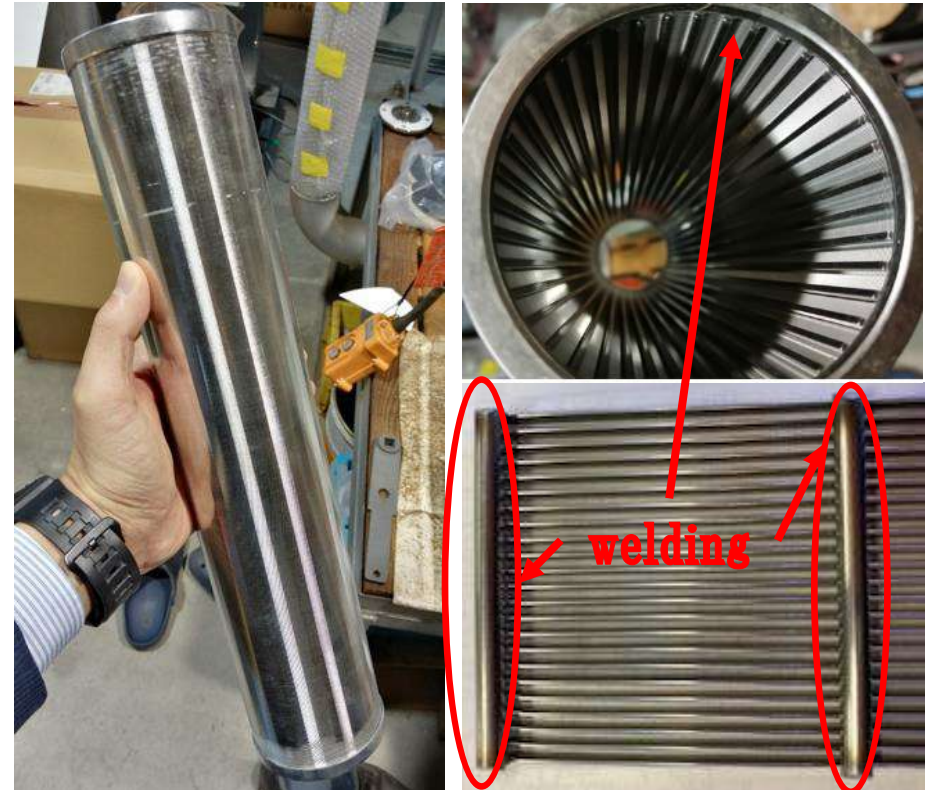
WEDGE WIRE ELEMENT

Weld all wires and support rods at intersection points

- THICKER WIRE THAN NOTED WIRE = MORE DURABLE

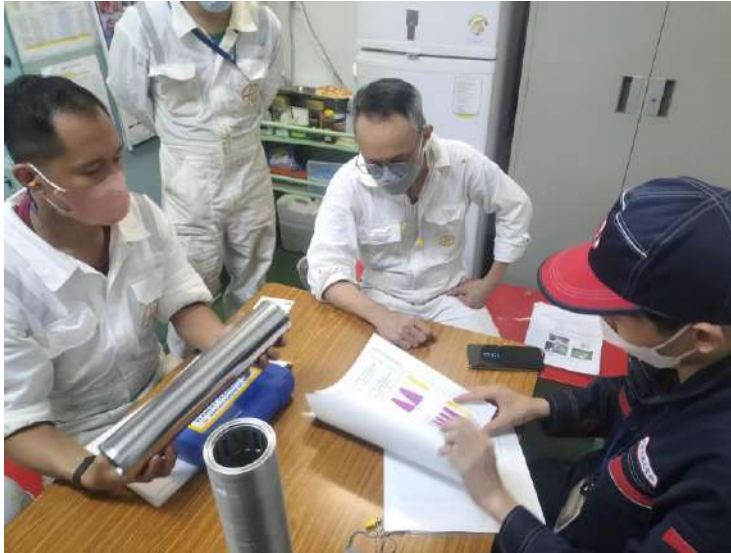
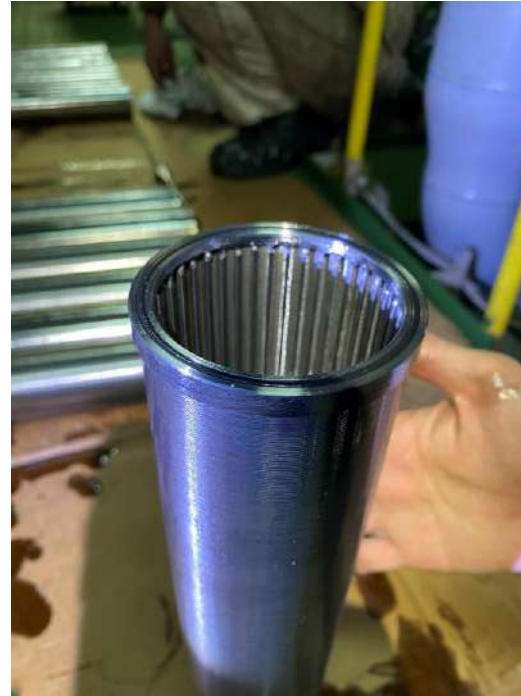
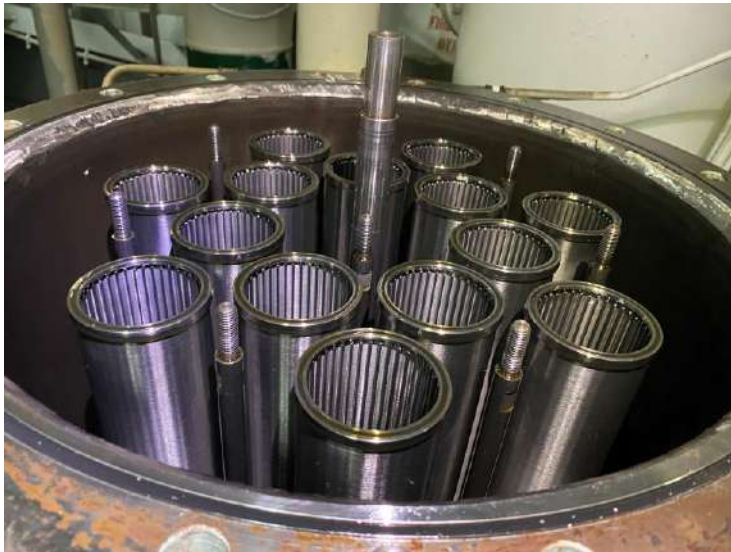
The new ELEMENT has already been installed on more than seven ships, and has not been operated at all for two years, including a single differential pressure switch.
